# Grease Sampling and Analysis for Wind Turbine Bearing Applications

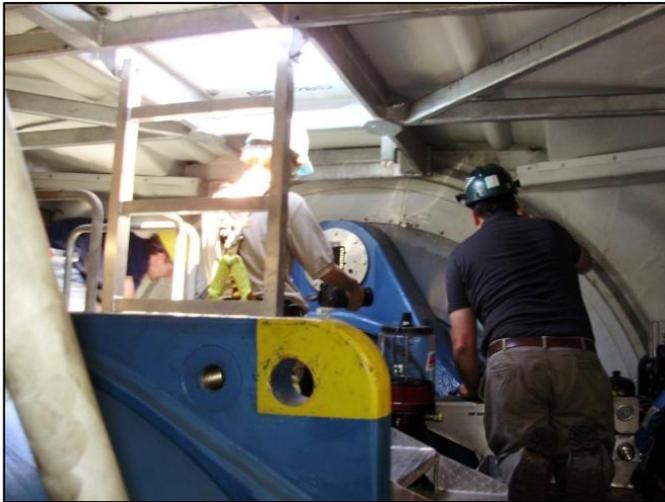
**Image 1.** Image shows samples being taken from a wind turbine

In this case study, grease samples were collected from wind turbines across multiple different wind farms. To ensure that a representative sample was obtained, grease sampling was performed per ASTM D7718 and analyzed per ASTM D7918. The grease screening test slate, which includes ferrous wear analysis via FerroQ, grease optical transmission via the Grease Thief Colorimeter, and FTIR analysis identifies outlier samples for further analysis at the laboratory. Data from these three tests gives insight into the wear rate, and any contamination of in-service greases. Action levels are determined by trending the results from an asset over time or comparing similar assets in a fleet.

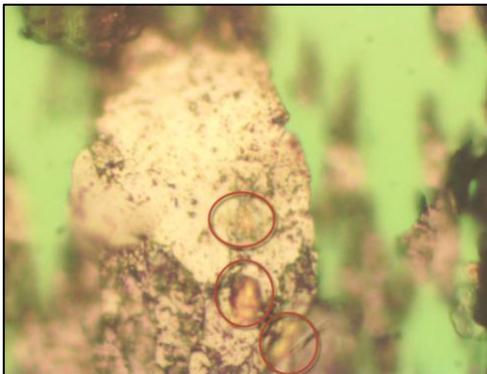
**Image 1:** A 500x magnification image of a lamellar wear particle ~50 microns in size. There are also copper alloy particles embedded on it (circled).

Within the ferrography image, there is evidence of rolling element fatigue which formed the large, flat lamellar wear particle. There are also copper wear particles in the image, meaning that a

copper component was wearing. With knowledge of the internal components of the wind turbine and their respective metallurgy, it was determined that the copper particles most likely came from cage wear.

In-service greases that have high ferrous wear identified via FerroQ can be candidates for further analysis in the laboratory to understand the wear present better. One valuable advanced test for wind turbine grease is analytical ferrography, which involves looking at wear particles under magnification to determine a root cause for the wear. Determining the root cause or type of wear can help to determine which wind turbines may need maintenance or an adjustment to the lubrication frequency.
